# Toilet:

A Final Frontier  
of PWD  
Accessibility

2023

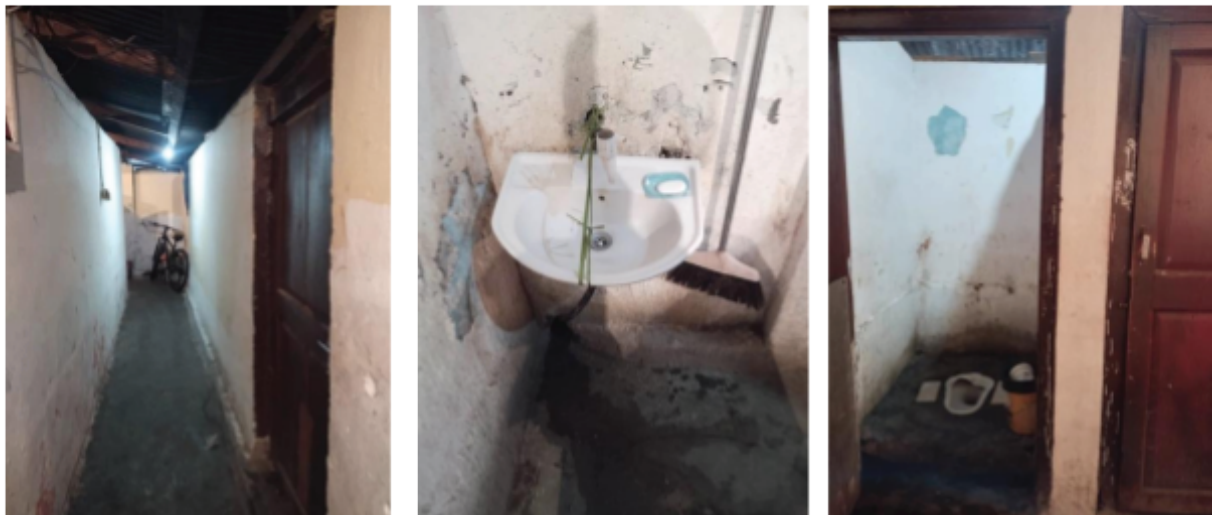
Figure 1 The hallway that leads to the public toilet, the hand washing sink and the lavatory (Source: Personal collection)

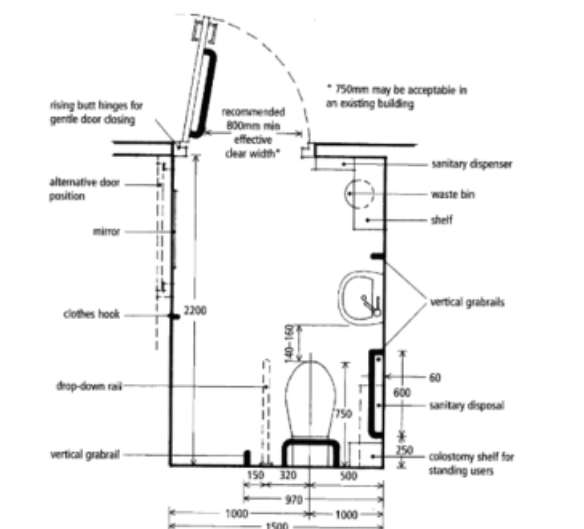
Figure 2: BS8300 (2001) Plan of Unisex wheelchair accessible washroom (Bichard et al., 2006)

The BS8300 toilet's inclusive design takes into consideration a wide range of disabilities compared to previous models, which were designed predominately for wheelchair requirements. BS8300 was the result of intensive research and consultations over 4 years. To ensure that the new standards were considerate of costs and practicality, which could hamper public compliance, the design development process involved measuring subjective comfort at different heights of fixture and fitting. The standards have evolved and improved over the years, and now they include considerations for several hidden disabilities.

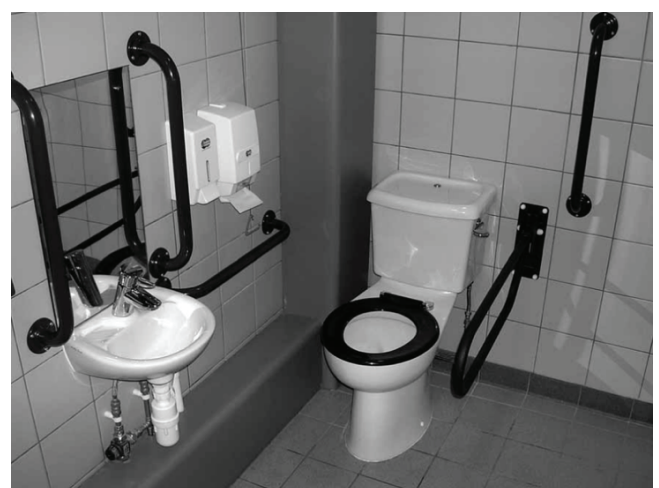
Figure 3: The unisex accessible cubicle (note: alarm incorrectly installed) (Bichard et al., 2006)

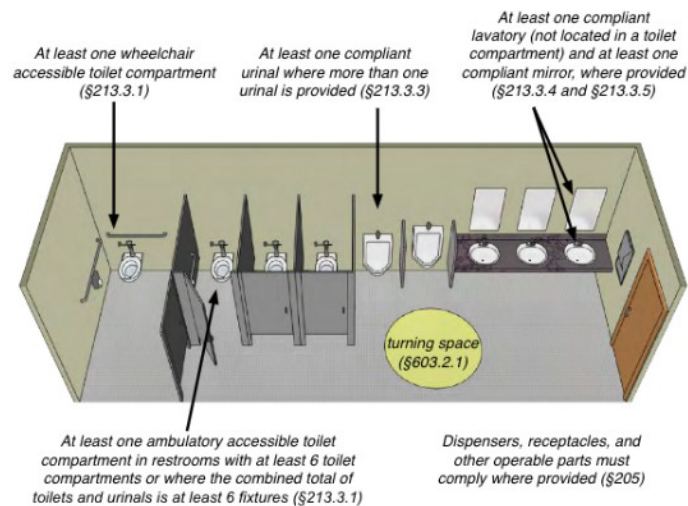
Universal Design can be applied to all types of public toilets, including multi-user toilets (with stalls) and temporary portable single-user toilets. In both cases, an accessible route and entrance and all the necessary fixtures and facilities apply along with all the provision for water closets, including those for grab bars and clearance.

Figure 4: Components of a multi - user toilet room (US access board, 2010)

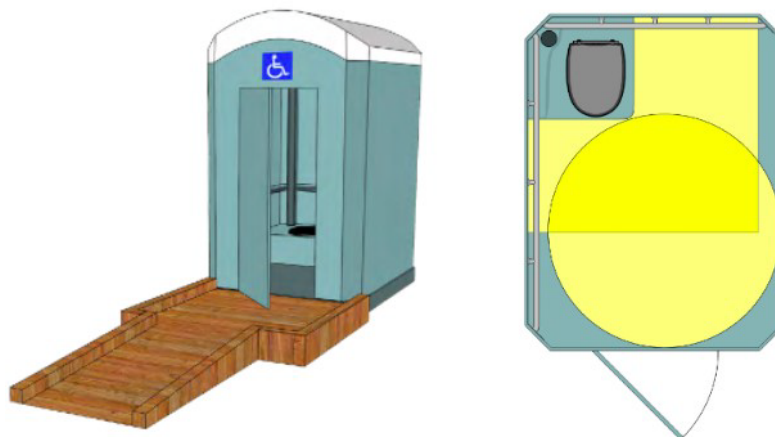
Figure 5: Portable Toilet unit (US access board, 2010)

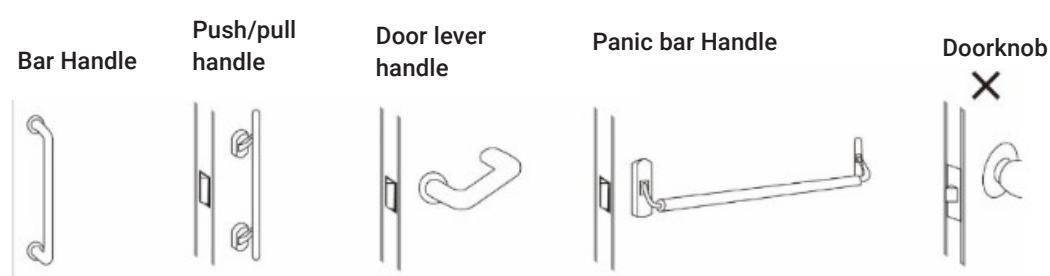
In terms of the entrance, the door location and the side clearance on the pull side should both be easy-to-use handles. Figure 6 shows easy-to-use door handles that don't need you to twist and turn and a doorknob that needs more exertion to open the door.

Figure 6: Example of easy - use door handle (Japan Association for the 2025 World Exposition , 2022.)

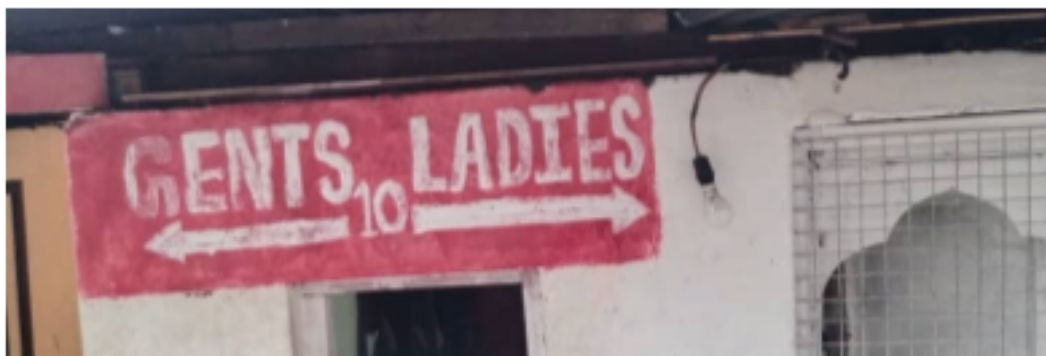
Figure 8: Wayfinding signage used in one of the public toilets in Bhutan (Source: Personal collection)

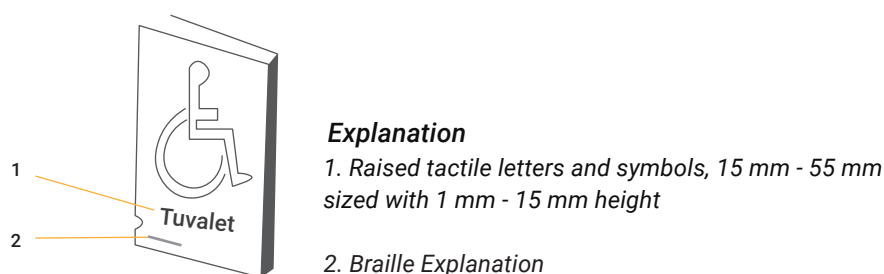
Figure 9: Raised tactile letters and braille (World Disability Federation, n.d)
